Manhole Inspection Summary

Manhole # S33EE2013MH

Insp Date: **12/19/06 9:18 AM**

Location Address: **100 MELROSE AVE**

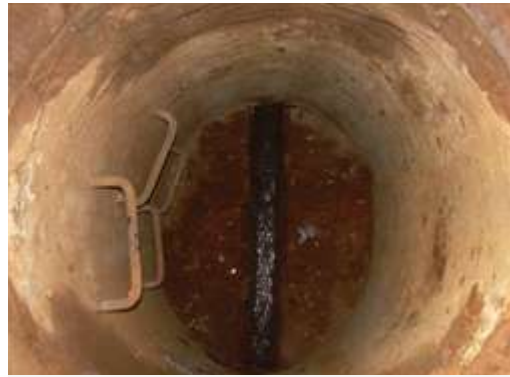
Top View

Bench debris.

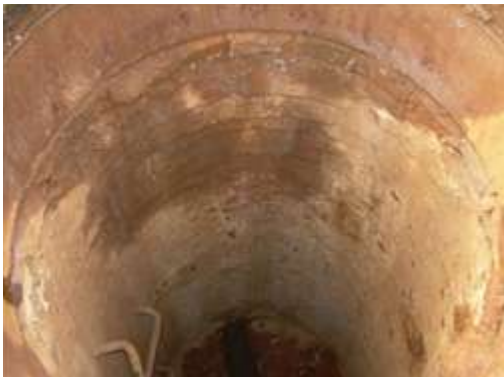
Defect

Adjustment deterioration, loose brick, and infiltration. Corbel and Barrel infiltration - other side.

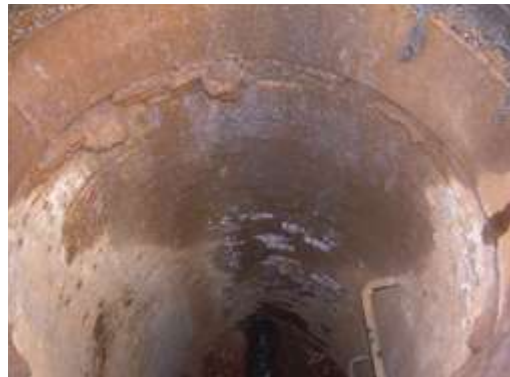
Defect

Frame leaks. Adjustment deterioration and infiltration. Corbel and Barrel infiltration.

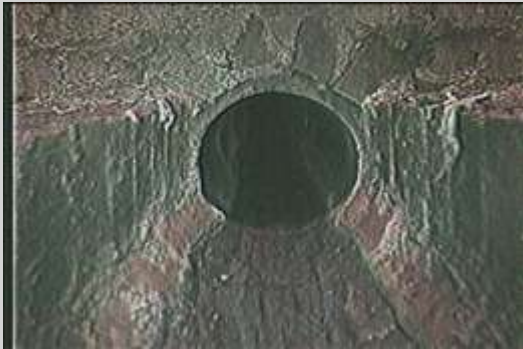
8 in. Circular Gravity Sewer Pipe Out @ 12 O'Clock

Infiltration: **Evidence** Pipe Seal Cond: **Unknown**

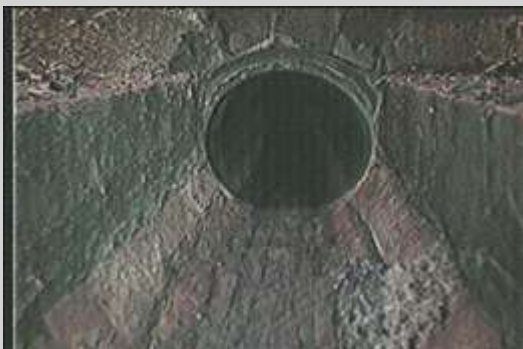
8 in. Circular Gravity Sewer Pipe In @ 6 O'Clock

Channel deterioration.

Infiltration: **Evidence** Pipe Seal Cond: **Unknown**
